MUMBAI HIGH NORTH ACCIDENT

Presentation to Oil & Gas UK Seminar: 6 June 2007

HSE Offshore Division

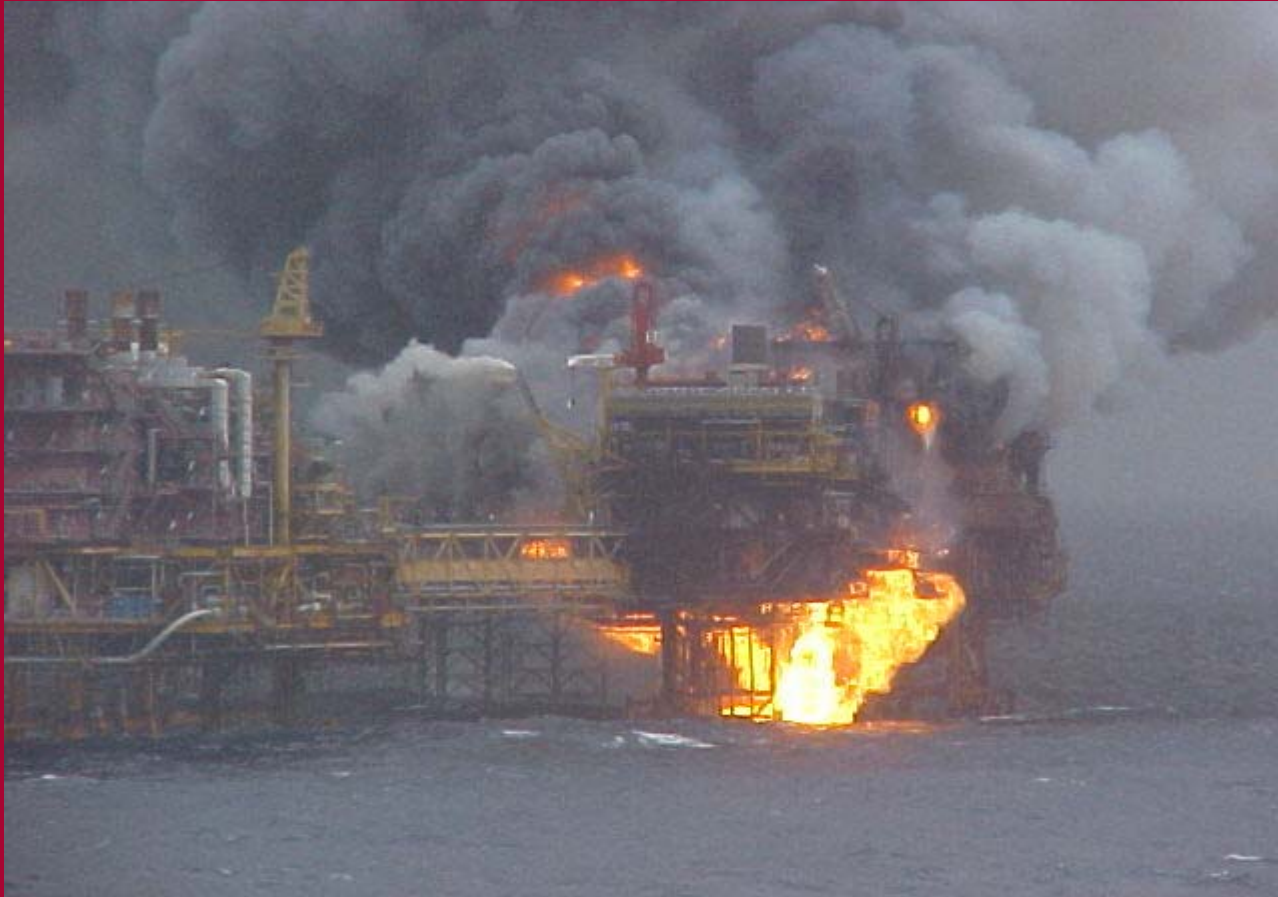
The fire

- Leeward crane on MHN was not working, so vessel came onto the windward side (wind 35 knots, swell 5 metres, sea current 3 knots).
- Problems with azimuth thrusters – came alongside under manual (joy stick) control in emergency mode, stern first. The casualty was transferred off the deck by crane
- The vessel experienced a strong heave, and the helideck struck the risers (export gas lift).
- The resulting leak ignited very quickly afterwards. The resulting fire engulfed virtually all of MHN and MHF, with NA and the Noble rig severely affected by heat radiation.

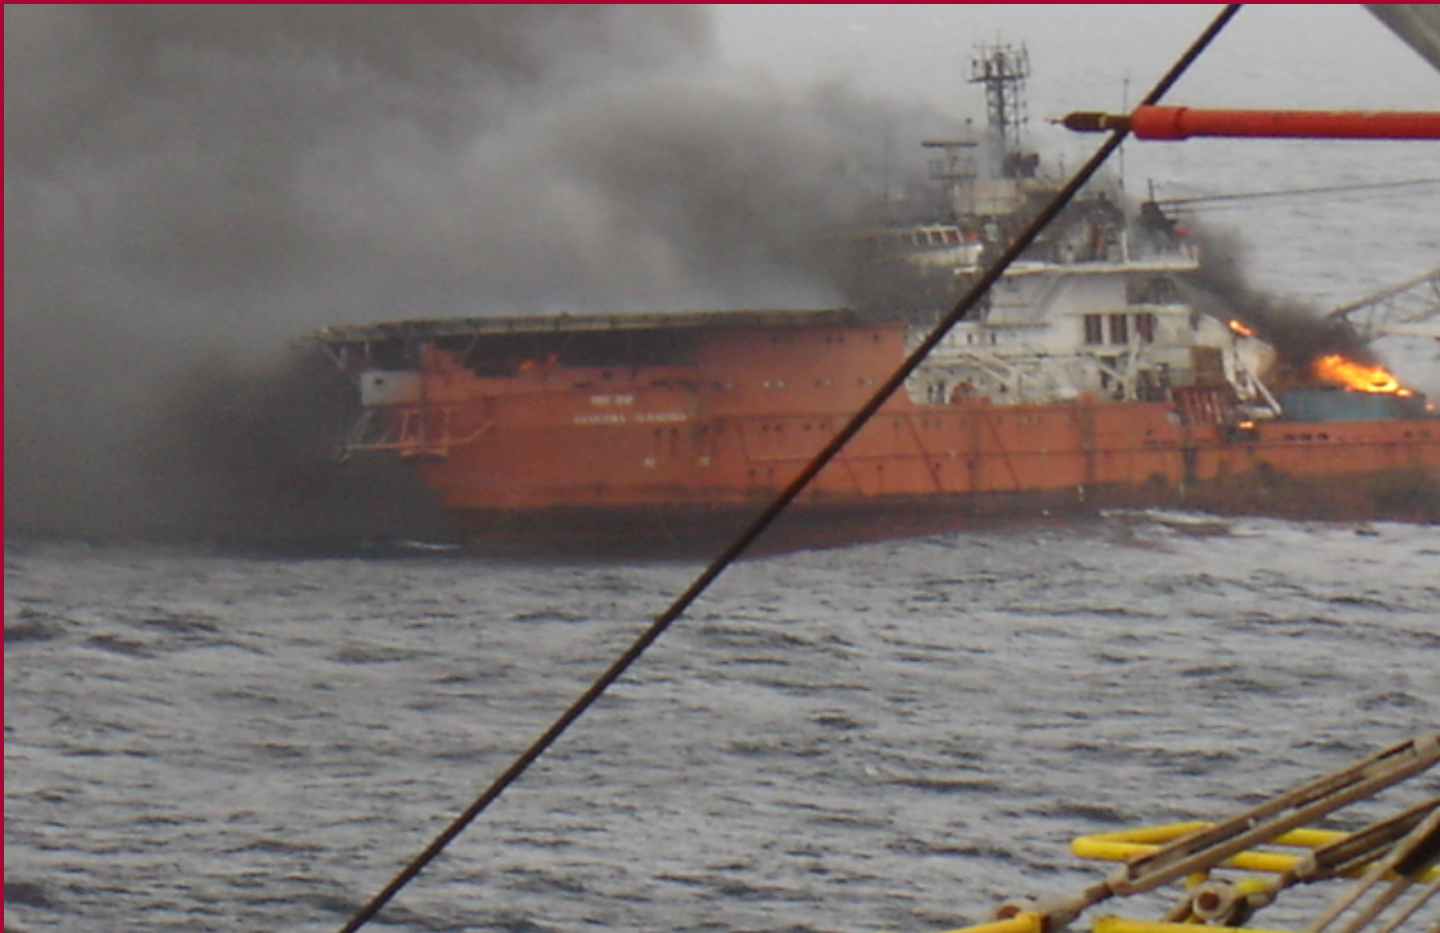
The MSV

- The fire occurred on 27 July 2005 - a multi-purpose support vessel (MSV), Samundra Suraksha, 100m long, hit one of the MHN platform risers.
- Vessel owned by ONGC but operated and maintained by another nationalised company, the Shipping Company of India (SCI).
- Vessel working elsewhere in the field, supporting saturation diving operations. Cook cut off the tips of two fingers, and transfer sought to MHN complex for medical treatment.
- Monsoon meant that no helicopters were available, so the vessel came alongside MHN to affect a man-riding basket transfer.
